# **Coalpac Pty Ltd**

## **Annual Environmental Management Report**

### **2014**

### **Cullen Valley Mine**

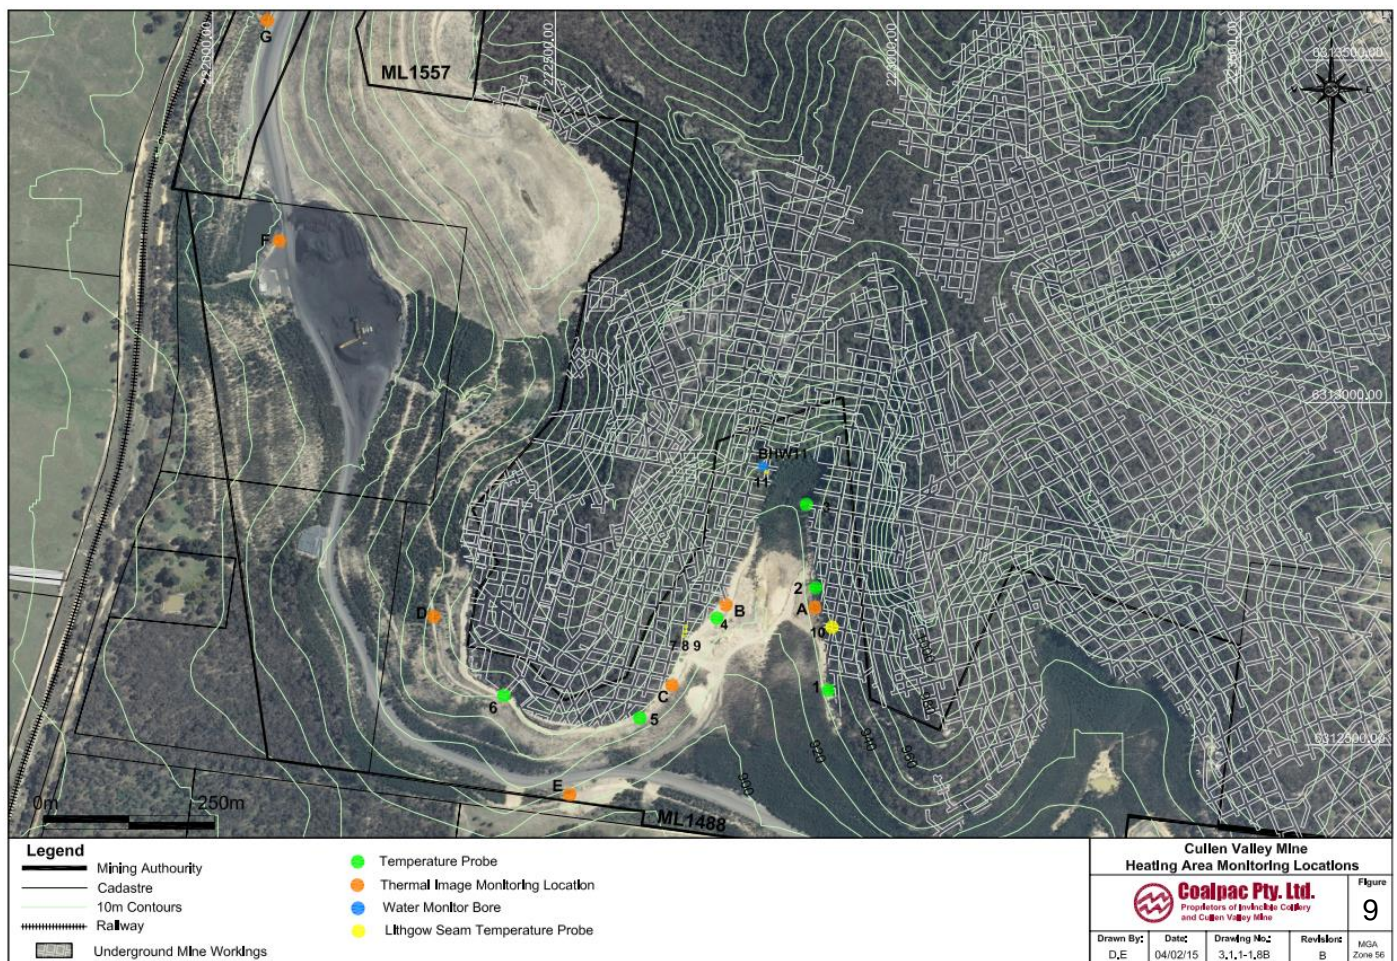
**Figure 9**  
**Heating Area Monitoring Locations**

It should be noted that the Cullen Valley Mine was placed in care and maintenance in December 2012 pending receipt of future planning approvals. The location of subsurface heating at Cullen Valley Mine and related monitoring points are shown on **Figure 9**.

Comparison of recorded sub-surface water levels show the level to be approximately 1.5m higher at BHW11 compared to the level in Tilley's Bore (the previously used reference point). This water level increase of 1.5m significantly improves the ability of the sub-surface water in the mine workings to act as a barrier for the potential migration of the fire to other areas of underground workings.

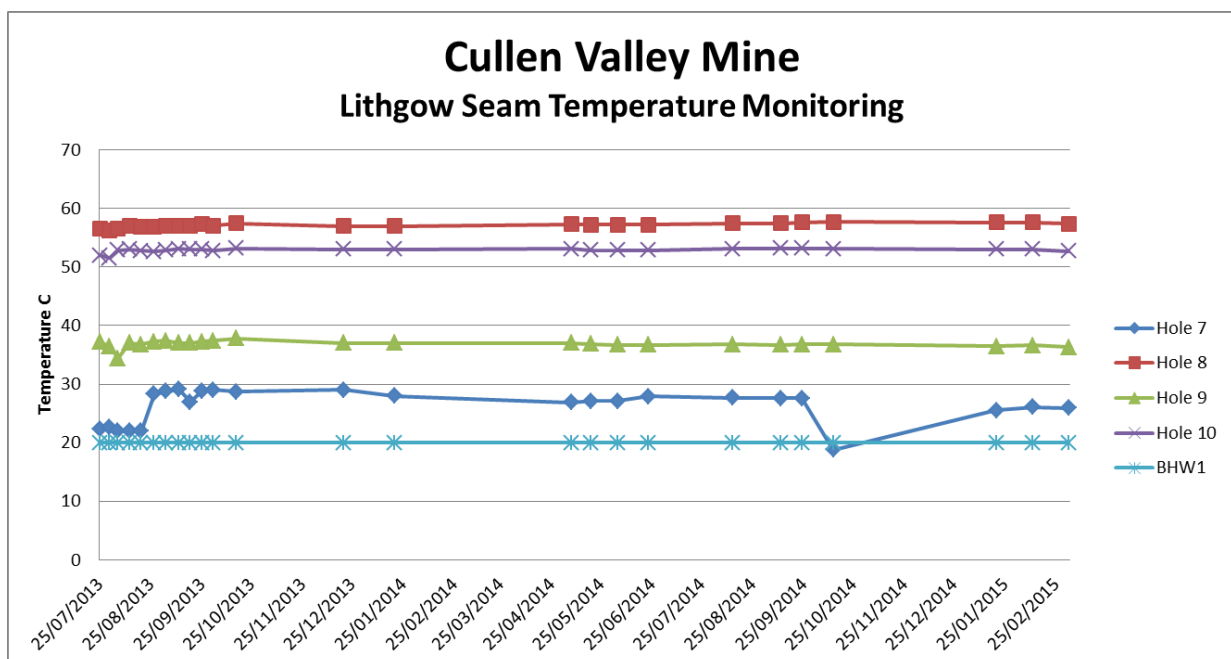
**Figure 10**  
**Lithgow Seam temperature monitoring results**

All the probes in Boreholes 1 to 6 have reached their use-by date and the data being recording is no longer reliable. It is OEC's recommendation that Coalpac cease recording from the current boreholes and replace selected ones (Current Boreholes 2, 5 and 6) with

The data continues to support the presence of a Dormancy Stage in the sub-surface heating in the underground workings around boreholes 7, 8, 9 and 10. In addition, the presence of sub-surface water in this area also reduces the likelihood of the heating spreading into the adjacent underground workings in this location.

The OEC recommendations provided in the January and September reports of 2014 recommendations are under consideration.

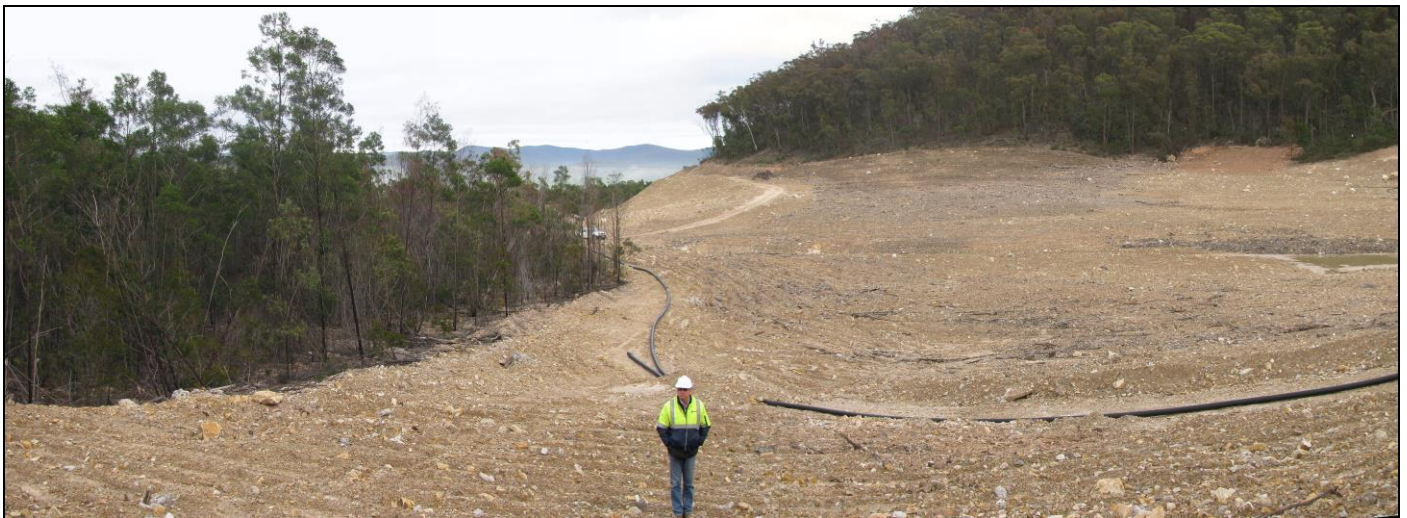
**Plate 2**

A large section of the main heating valley has been capped and smaller isolated heating areas have been capped where observed within the open cut backfill sectors. To date all heating affected zones are located in areas mined prior to Coalpac purchasing the Mine in 2007.

**Capped area, no signs of active heating during thermal survey (May 2014)**

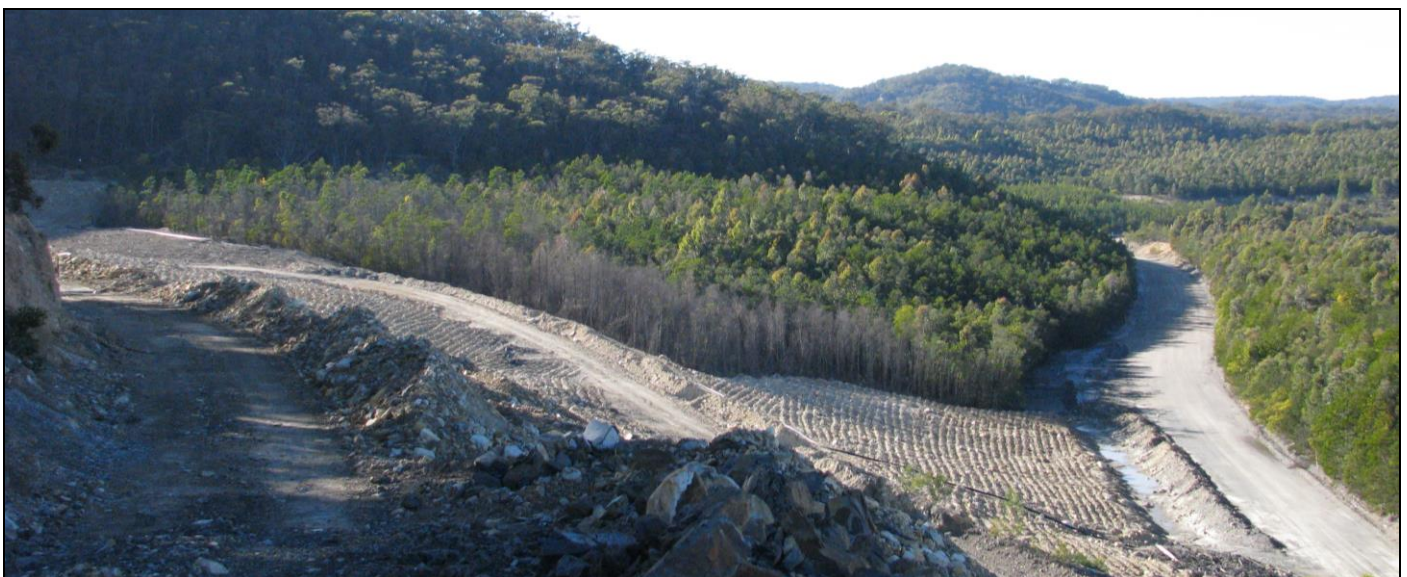
**Plate 3**

**Capped area against haul road (Aug. 2014)**

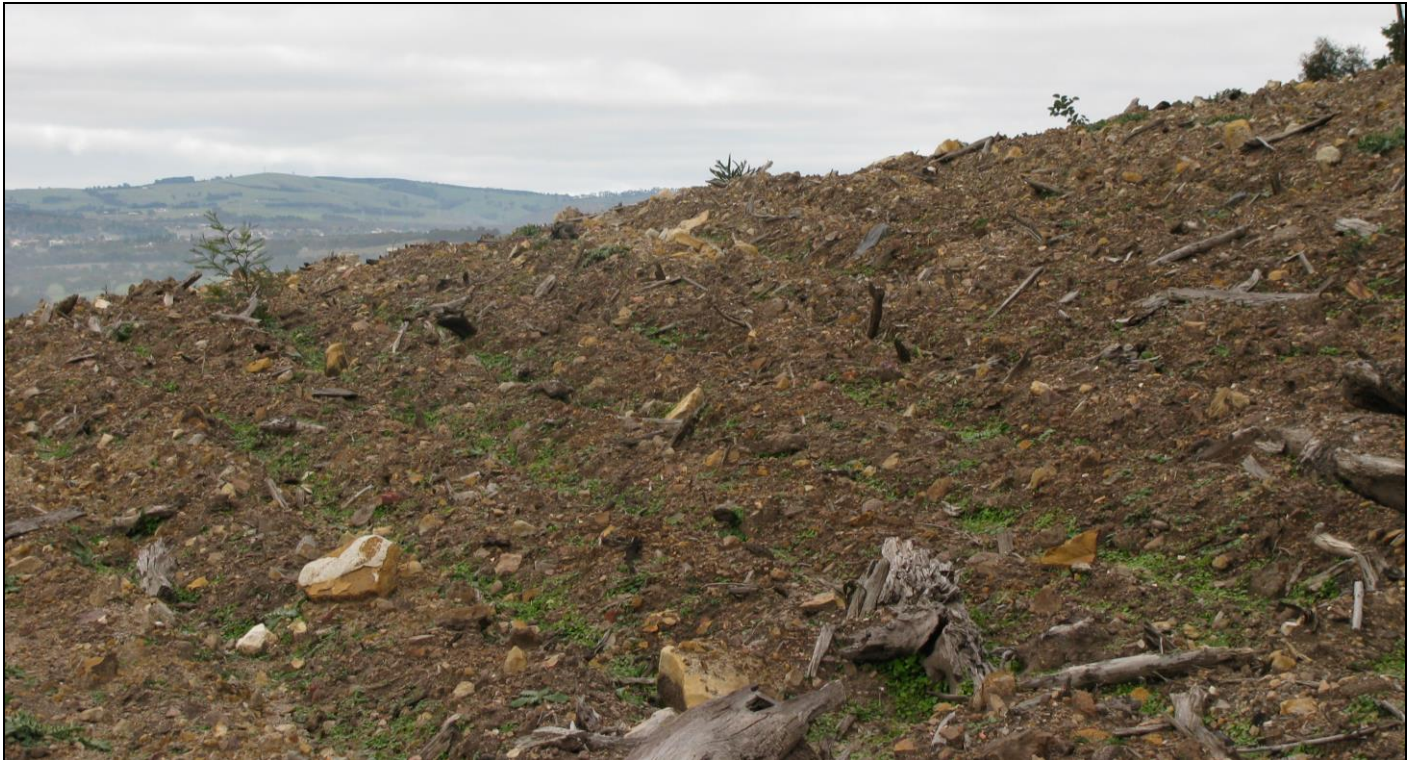
**Plate 4**  
**Natural regeneration in main valley area (May 2014)**

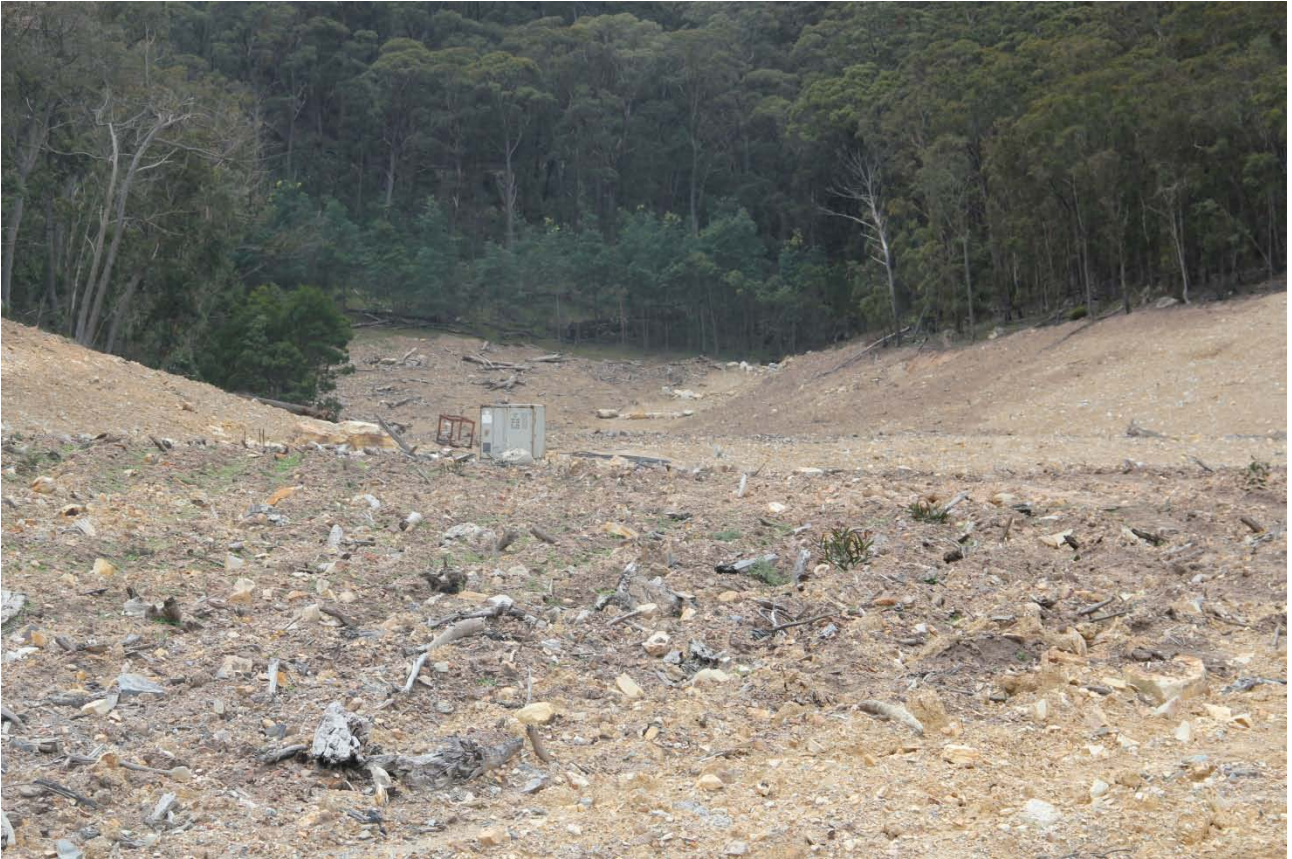
**Photograph 1. Area B looking north 8/9/14**

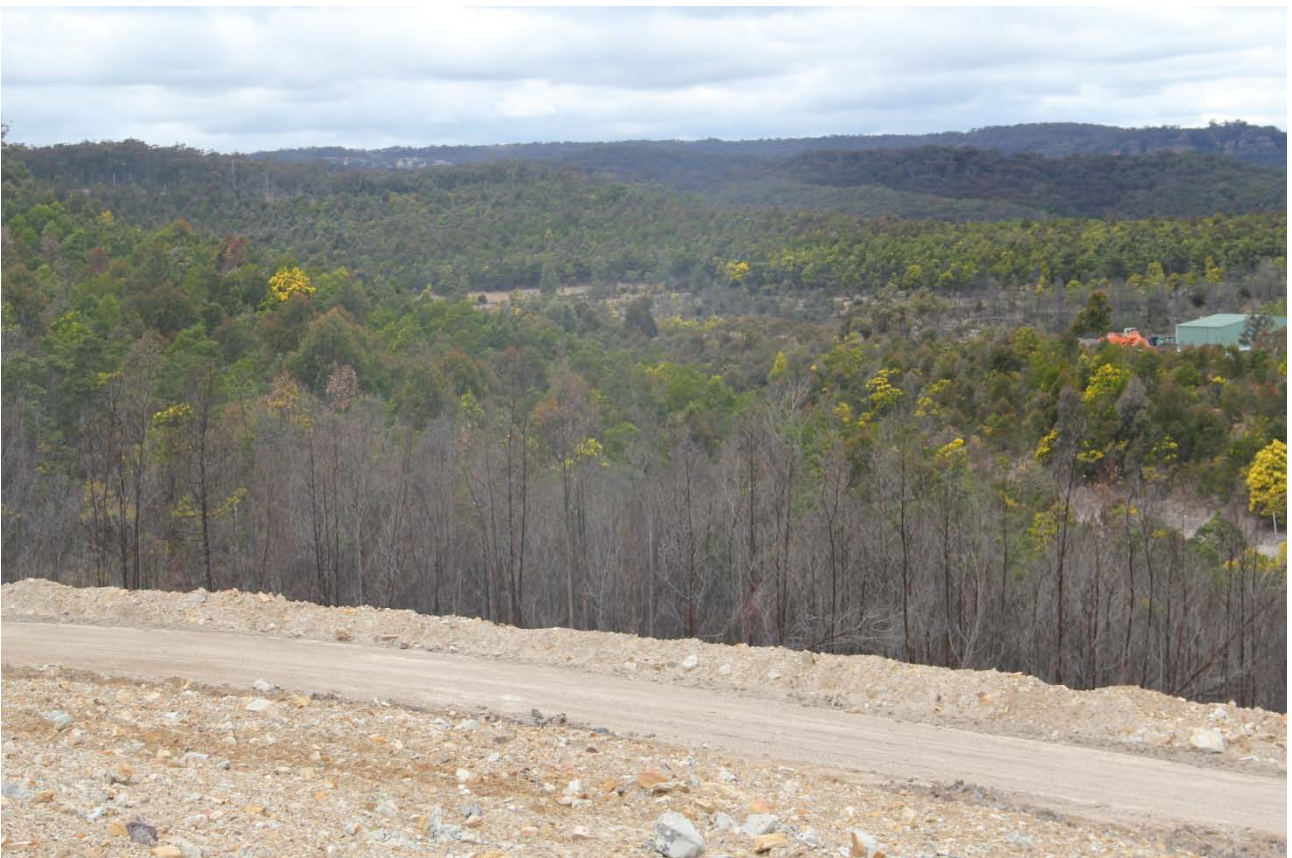
**Photograph 2. Heat affected Vegetation. Areas at Boundary of Areas B, C and R 8/9/14**

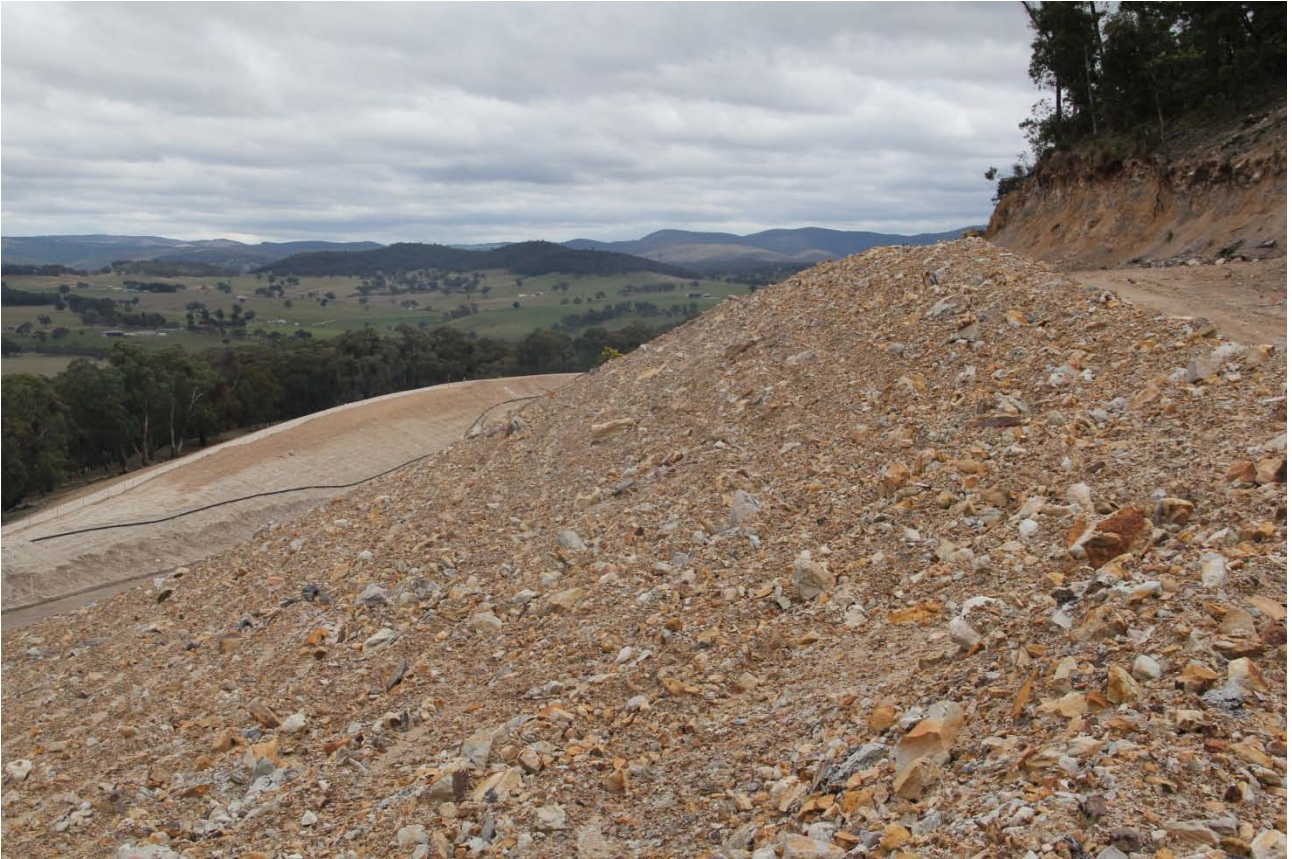
**Photograph 3. Area C with Haul Road Noise Wall in mid ground 8/9/14**

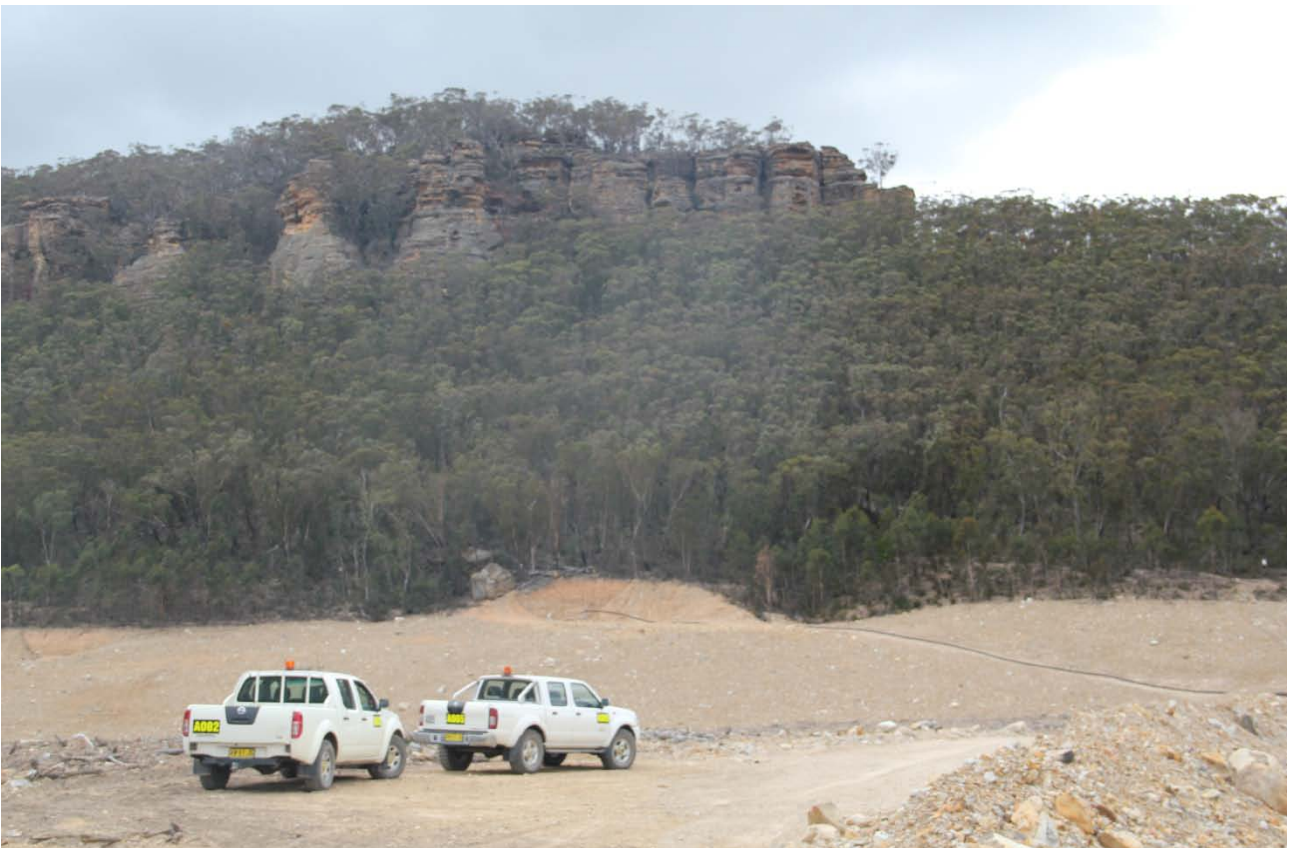
**Photograph 4. Area B looking east 8/9/14**
