CULLEN VALLEY MINE ANNUAL REVIEW

1 JANUARY 2016 – 31 DECEMBER 2016

Prepared by
Umwelt (Australia) Pty Limited
on behalf of
Shoalhaven Coal Pty Limited

Report No. 3968_R02_Annual Review

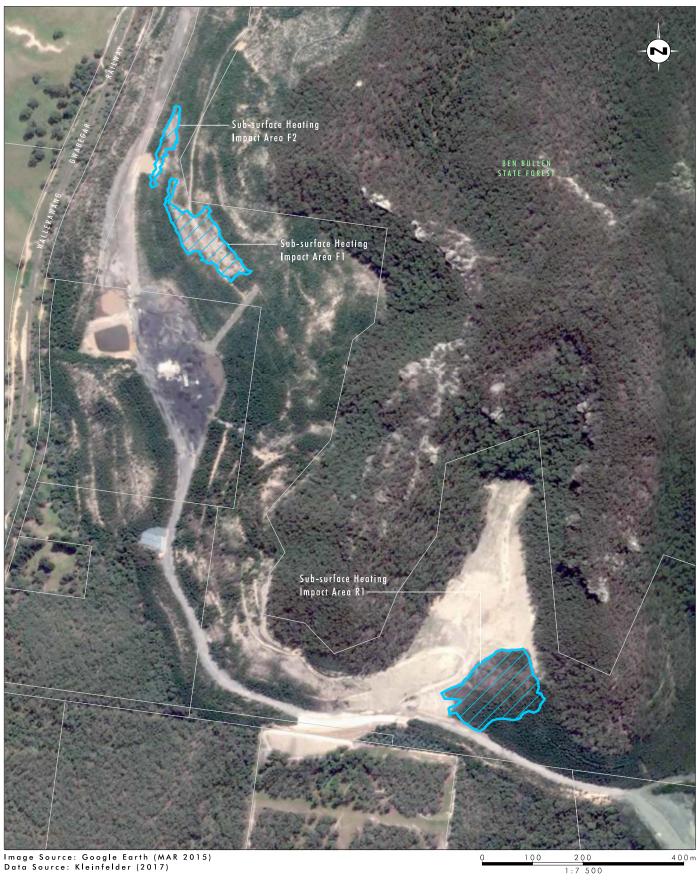
During 2016 DRE inspections of the site, DRE have noted that there are still a number of areas where subsurface heating had caused vegetation dieback. The main subsurface heating areas are known as R1, F1 and F2 and are shown on **Figure 6.4**.

Sub-surface Heating Impact Areas

Heating Area	Works During 2016	Action for 2017
R1	heating and dieback had expanded during late 2016 and has not yet been capped.	 During 2017, further investigation will be undertaken into capping methods and requirements for the site. Actions such as capping and sealing subsurface heating cracks, which have been used effectively at the F1 and F2 heating areas should be considered.
F1	heating area was capped during 2015 / 2016.	The expansion and dieback of vegetation appeared to be contained. Capping had been undertaken through the utilisation of earthworks. Ongoing monitoring will be undertaken for this area to confirm heating remediation has been adequately completed.
F2	 minor vegetation dieback had occurred. cracks had appeared due to escaping gases from the underground spontaneous combustion process. concrete has been used to fill the subsurface heating cracks. 	 during 2017, further investigation will be undertaken into the heating in this area and appropriate remediation techniques employed as required.
