CULLEN VALLEY MINE ANNUAL REVIEW

**1 JANUARY 2017 –
31 DECEMBER 2017**

Prepared by
Umwelt (Australia) Pty Limited
on behalf of
Shoalhaven Coal Pty Limited

Project Director: Luke Bettridge
Project Manager: Luke Bettridge
Report No. 3968_R35_Annual Review
Date: March 2018

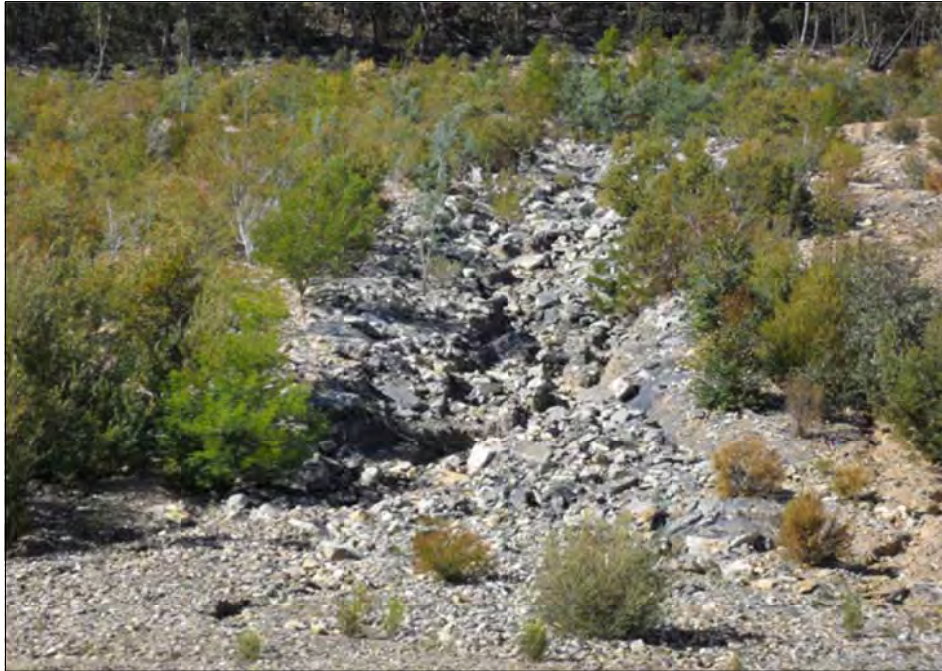
PLATE 1
Drop Structure 2 Repairs
Before

In May 2017, works were undertaken to repair a number of existing drains and drop structures, refer to **Plates 1 to 4**.

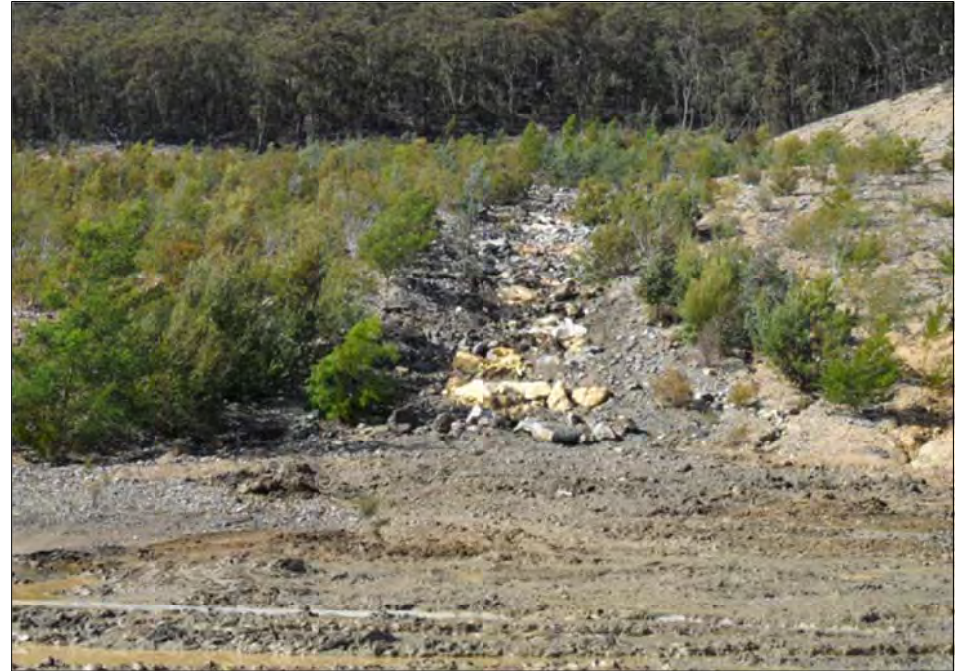
PLATE 2
Drop Structure 2 Repairs
After

As detailed in **Section 6.8.3**, during the reporting period works were undertaken to repair drainage structures and existing erosion on site. Visual inspections of the erosion control repairs has indicated that the repaired structures are operating as intended, with the performance of these erosion control structures to be reviewed during 2018.

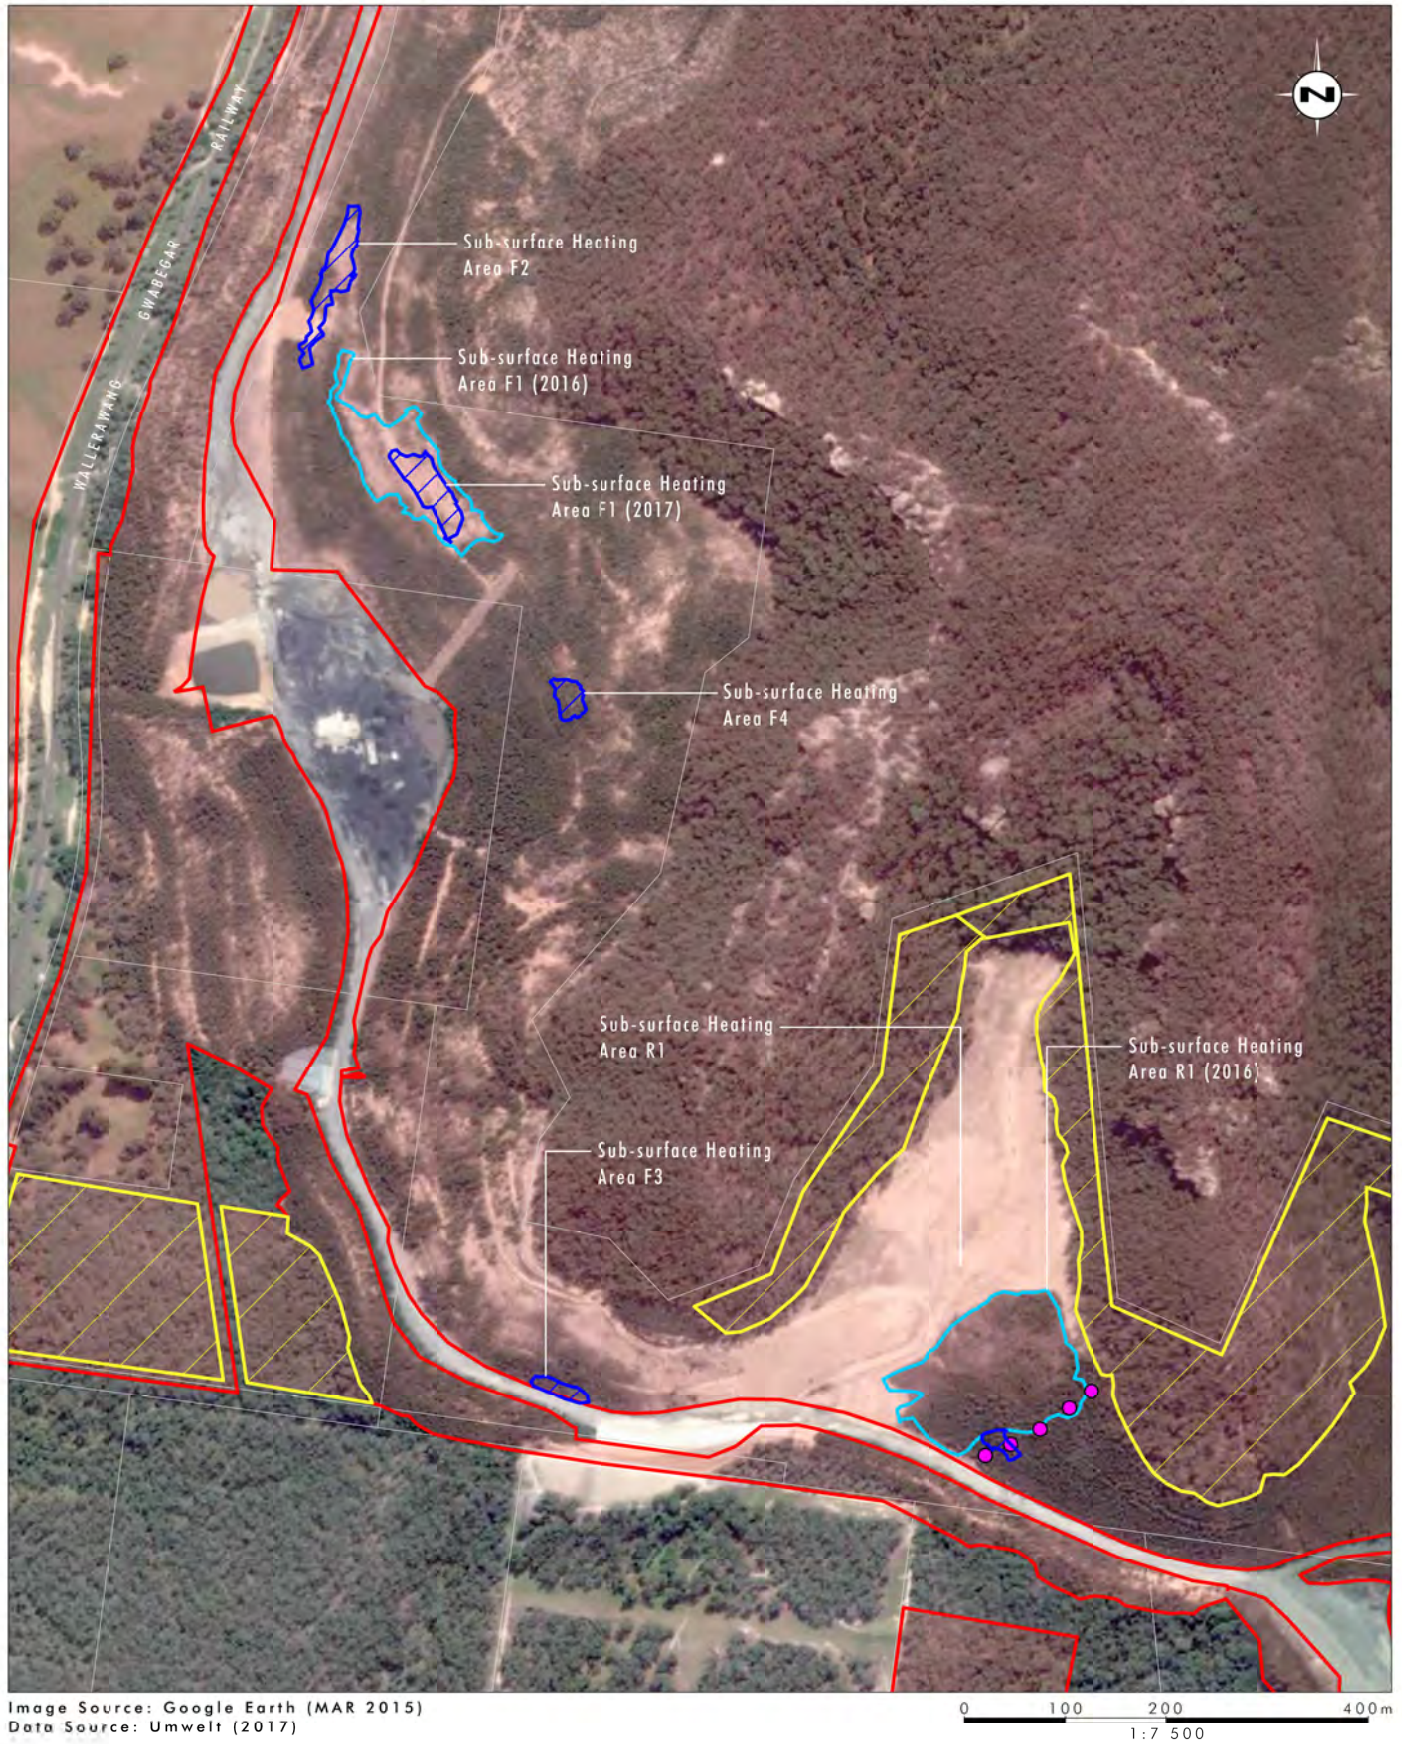
Subsurface heating at CVM has been observed to occur in three main areas on site being area R1, F1 and F2 (refer to **Figure 6.5**).

Two additional heating areas (i.e. F3 and F4) were identified at CVM during 2017. These areas have been monitored as part of the 2017 ecological monitoring program. Both areas presented early signs of subsurface heating (e.g. foliage dieback and subtle burn marks at the base of trees and shrubs). Subsequent monitoring surveys will provide an indication of how subsurface heating impacts the area over time and when management intervention should occur. The ongoing management of these areas will be undertaken with the management measures as detailed in the CVM C&M MOP (Sedgman, 2015).

During 2017, further inspection of vegetation dieback areas was undertaken as well as ongoing monitoring of subsurface heating areas, refer to **Figure 6.5**. Minor works (i.e. localised earthworks – excavation of cracks and backfilling with inert material and compacting and filling cracks with concrete) was undertaken in Areas R1. Monitoring and treatment of heating areas will continue during 2018.

- Weekly monitoring of heating areas;
- Capping of surface cracking using cement; and
- Excavation and compaction of material as required.
