CULLEN VALLEY MINE ANNUAL REVIEW

1 January – 31 December 2020

March 2021

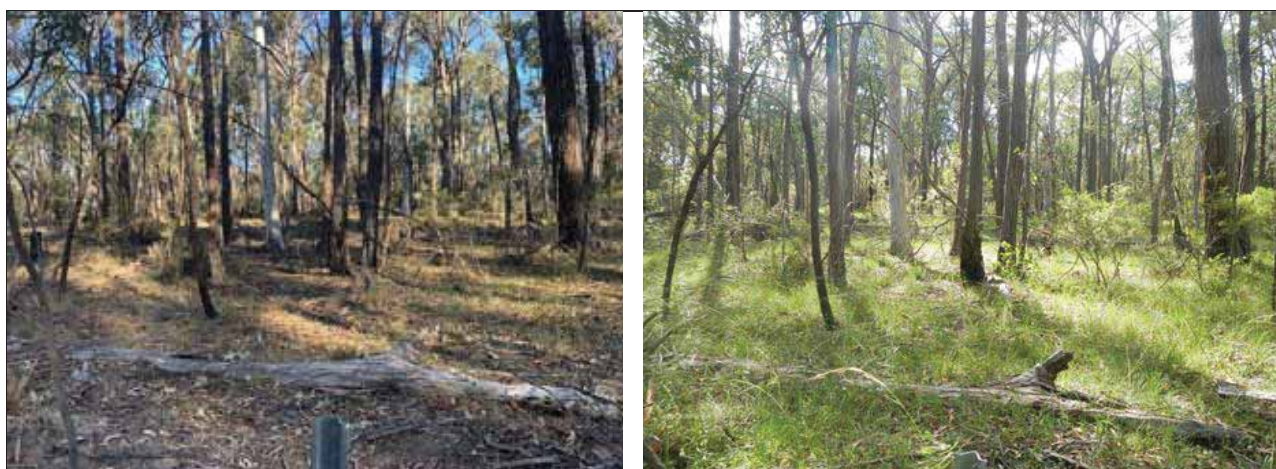
Native vegetation within the Compensatory Habitat Areas was considered to be in good condition across all woodland and forest habitats however it was found to be affected by previous drought conditions. Monitoring in 2020 recorded a significant increase in the overall floristic composition and vegetation condition for most Compensatory Habitat Area monitoring locations compared to monitoring in 2019. Woodland and forest habitats demonstrated substantial increase in the vegetative cover throughout the ground stratum (**Plate 6.2**), whereas foliage cover in the canopy while the midstory strata was generally sparse and continues to recover following the drought. In 2020 bare earth was infrequently observed across all Compensatory Habitat Area monitoring locations. Where ground layer vegetation was present an increase in native species diversity was observed, compared to 2019. The vegetation of the Compensatory Habitat Areas demonstrates minimal degradation due to human influences with the exception of vehicle tracks, minor logging and rubbish dumping by others. Given the above information, no flora management activities are recommended at this time. While the 2020 monitoring observed increased cover and abundance of native species it should be noted that the cover and abundance of these species is expected to decrease slightly in subsequent monitoring events as is typical of native flora species following a period of increased growth after a drought.

Plate 6.2 Condition of CHA monitoring location CH6 (Left - 2019; Right - 2020)

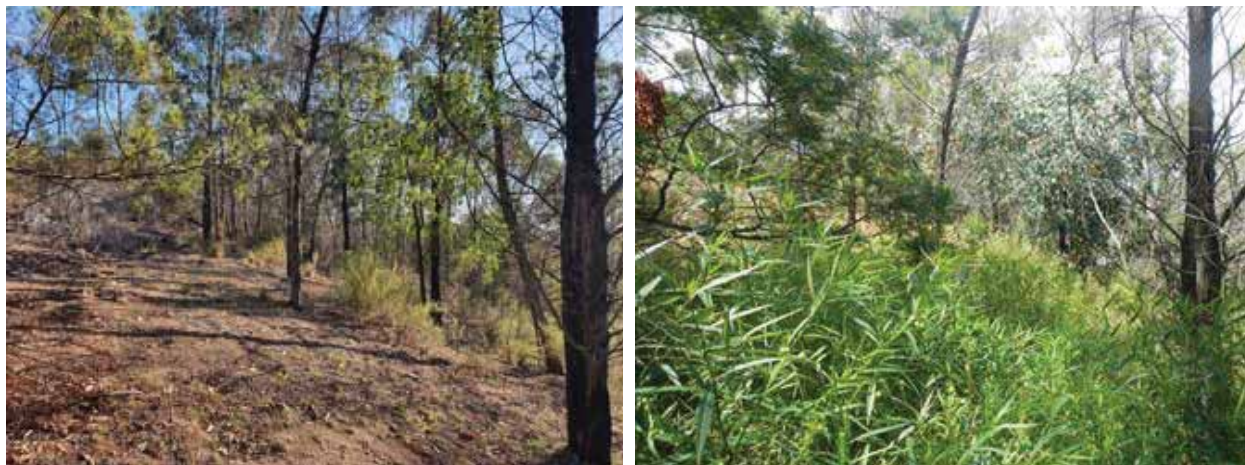
During the 2020 monitoring, a significant increase of vegetative cover was observed within the ground strata of the monitoring sites within the Rehabilitation Zones. This is a marked difference to the low ground cover recorded in 2019 indicating that the vegetation within the Rehabilitation Zones is recovering post-drought (**Plate 6.4**). The middle and upper strata within the Rehabilitation Zones continued to show some form of dieback, likely due to the drought and natural senescence of acacia in particular. However, it is expected that the species within these strata will continue to recover over time. Encouragingly, the presence of the mycorrhizal orchid species (*Calochilus sp.*) recorded at monitoring site R1 is an indication of ecosystem functionality of the Rehabilitation Zones. Approximately 10 mycorrhizal orchids were recorded during the 2020 surveys whereas no records were observed in 2019 and only one record observed in 2018.

Plate 6.4 Condition of CVM Rehabilitation Monitoring Location FP6 (Left – 2019; Right – 2020)

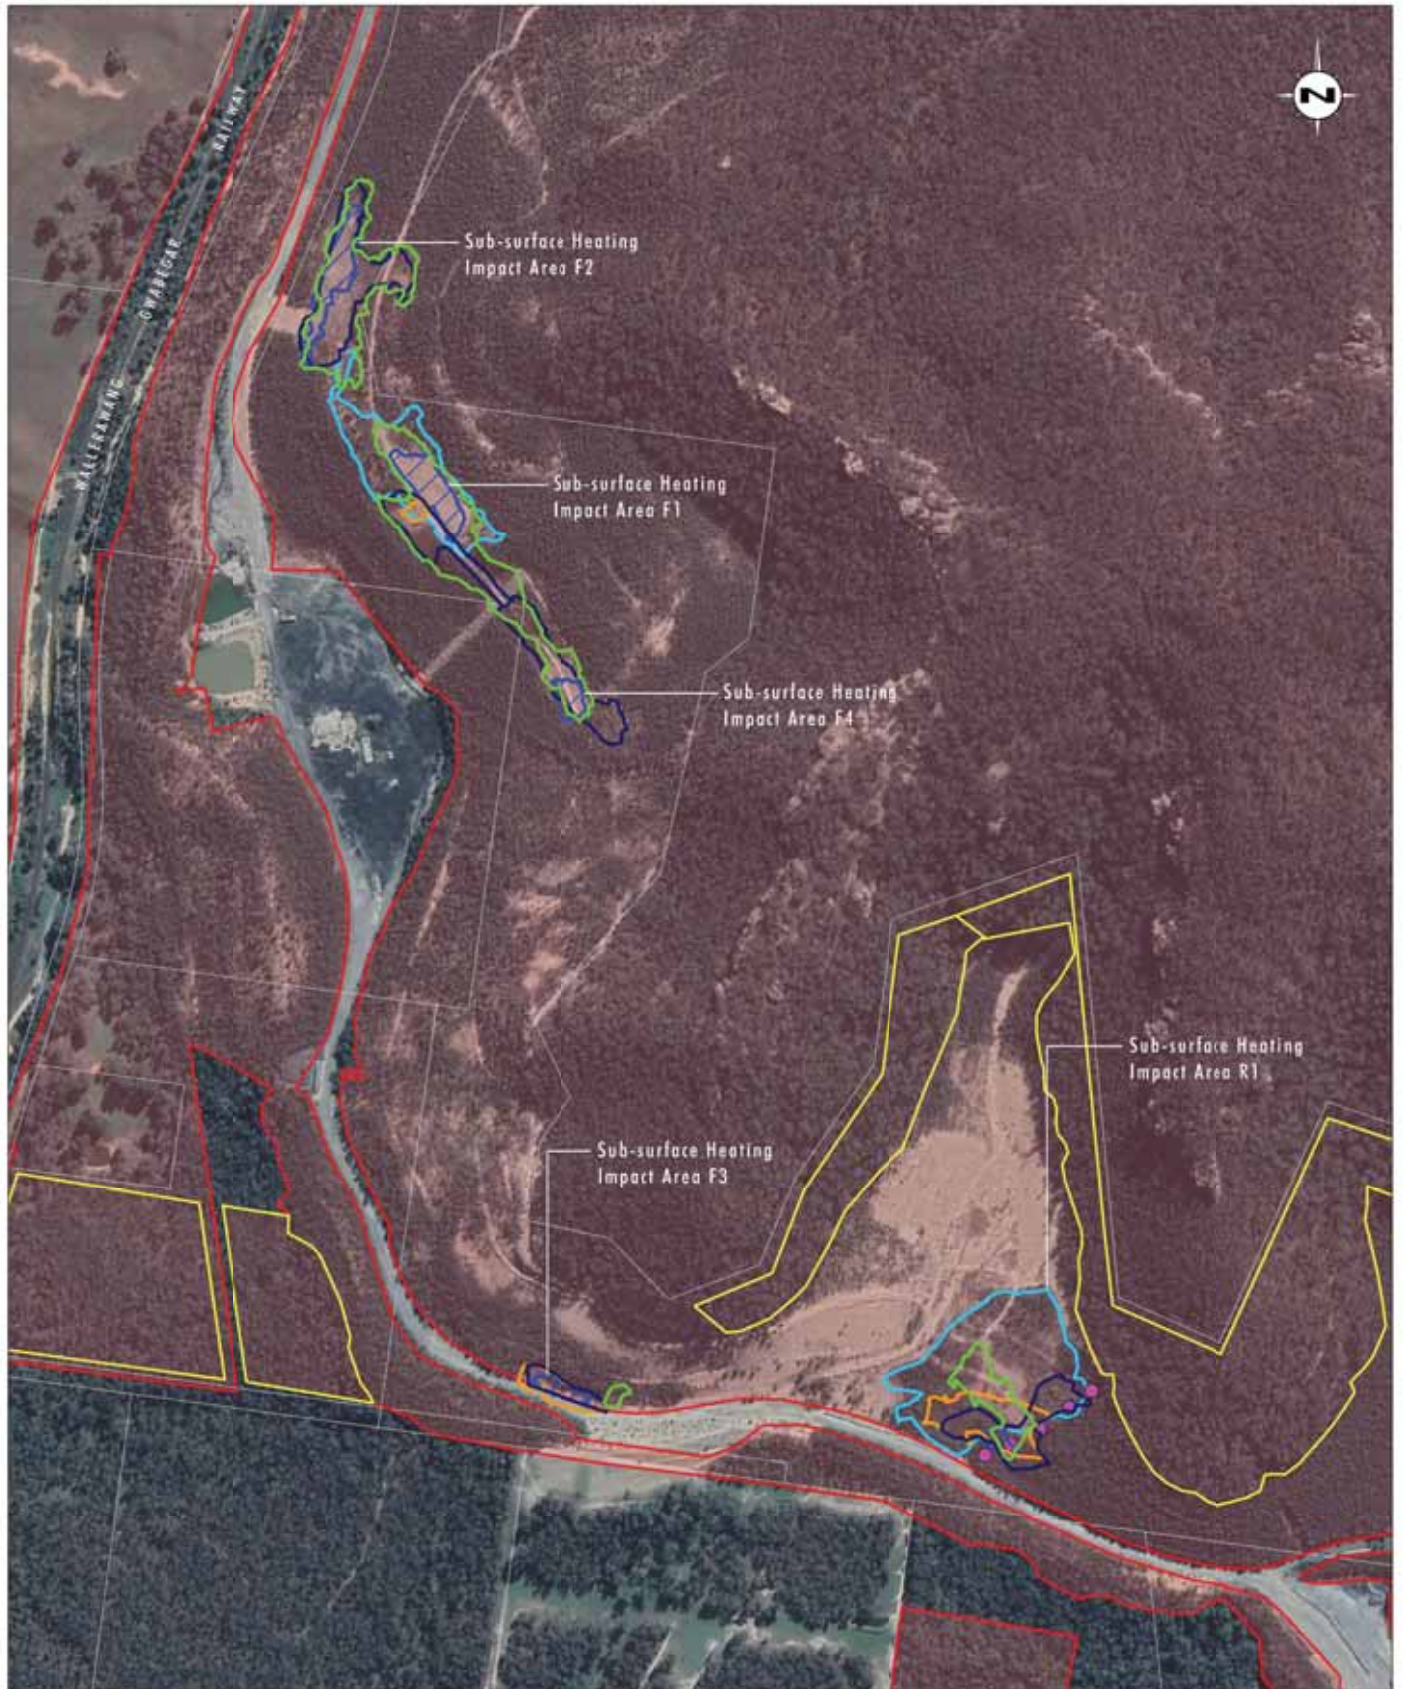
Subsurface heating at CVM has been observed in five main areas being area R1, F1, F2, F3 and F4 (refer to **Figure 6.4**). The active extent of the subsurface heating has been mapped for applicable years (**Figure 6.4**).

During 2019, minor repair works (i.e. localised earthworks – excavation of cracks and backfilling with inert material and compacting and filling cracks with concrete) was undertaken in subsurface heating areas with the exception of Area F3.

During 2021, CVM will continue to monitor for subsurface heating and undertake treatment measures in accordance with the updated Plan of Works (**Section 6.9**). Further investigations into subsurface heating sources and potential treatment methods will also continue (**Section 6.9**).
