# **Coalpac Pty Ltd**

## **Annual Environmental Management Report**

### **2014**

### **Cullen Valley Mine**

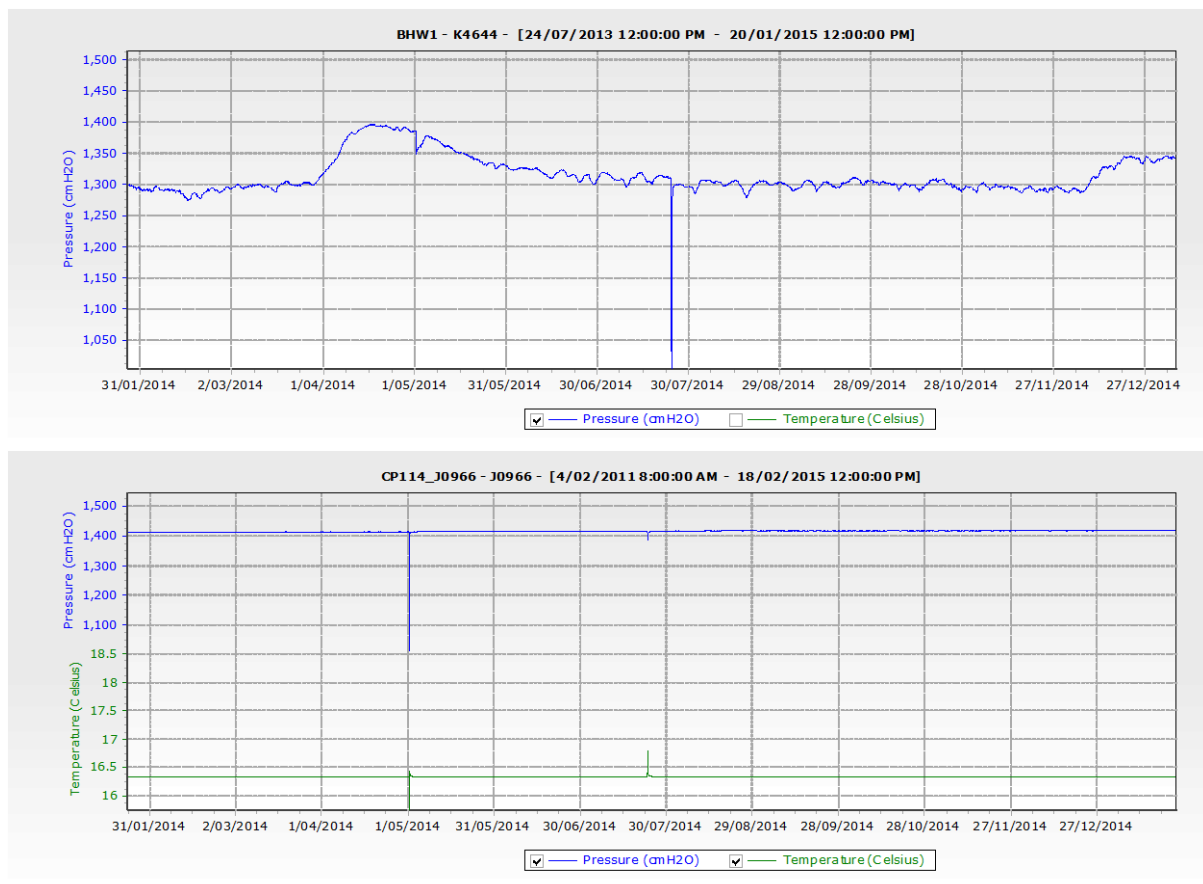
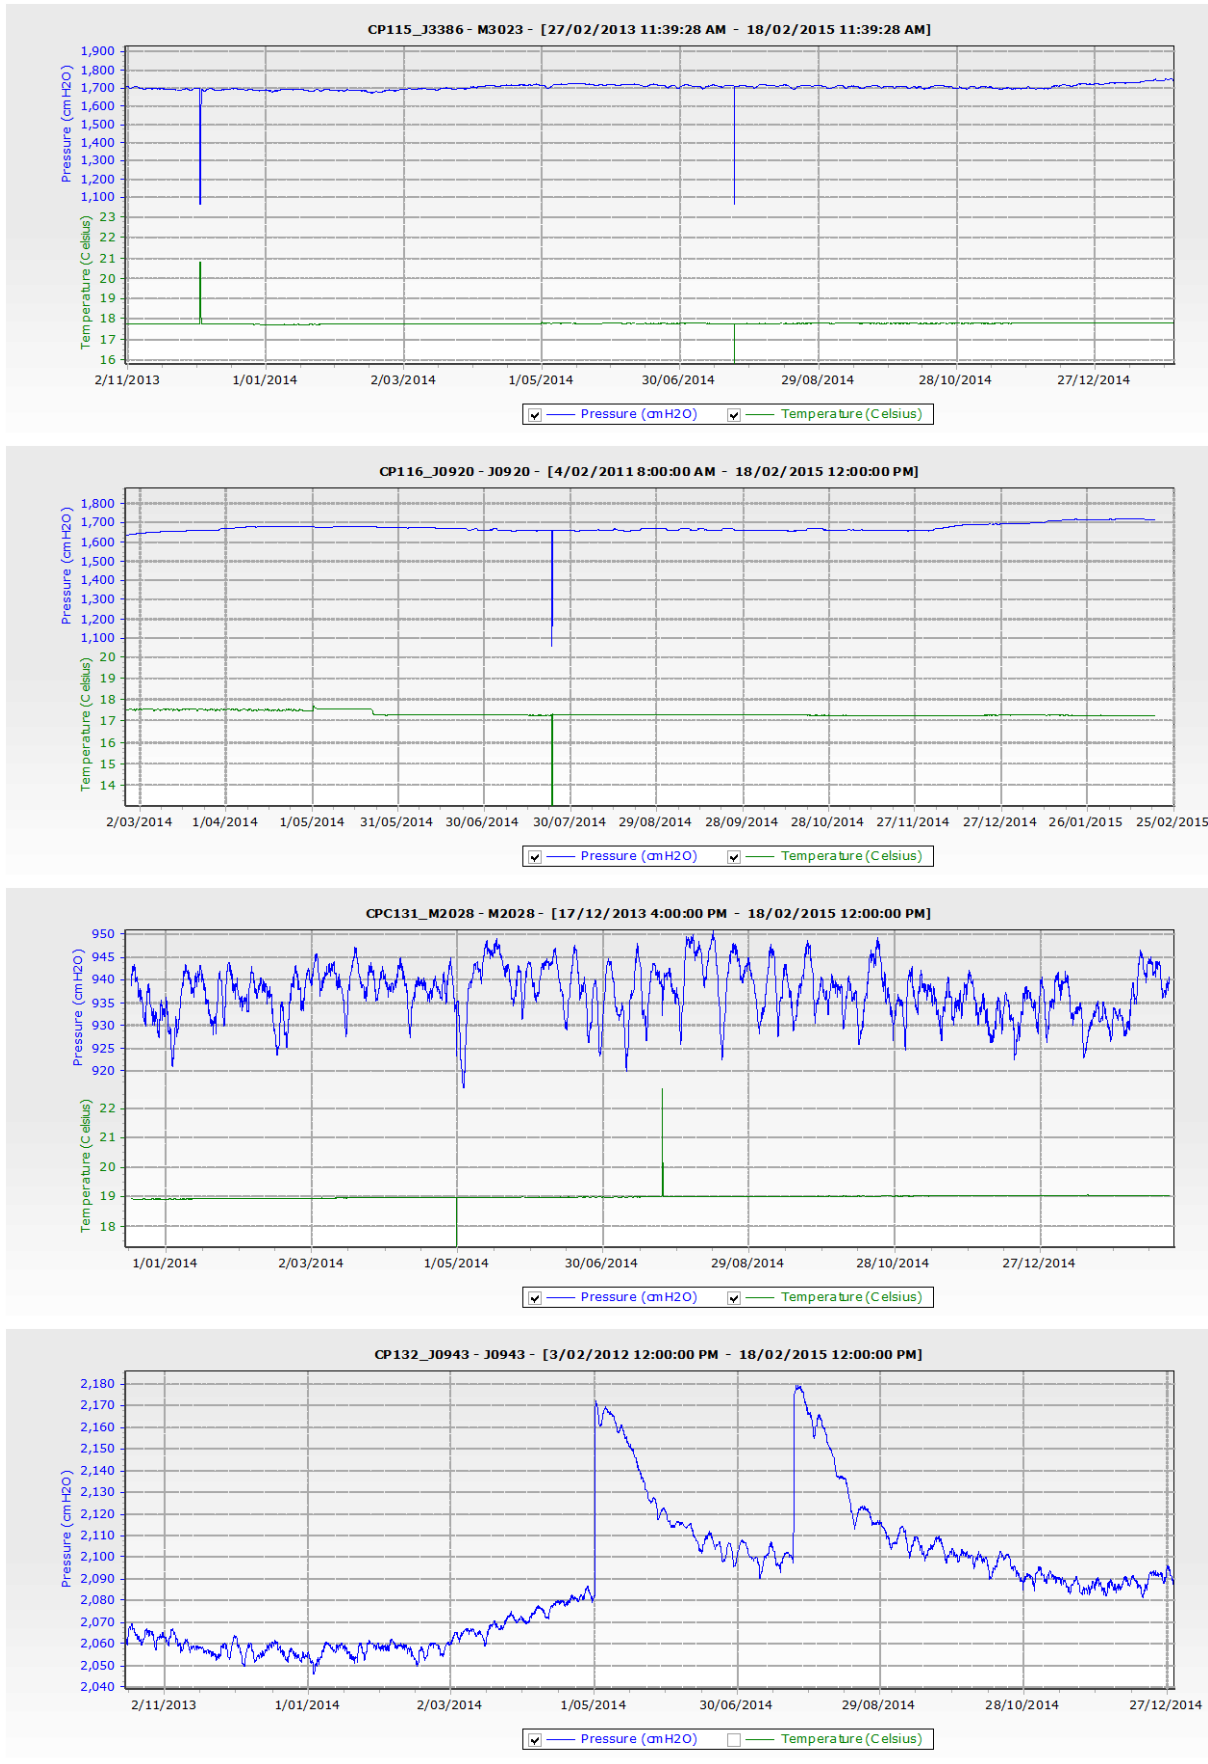
**Figure 8**  
**Groundwater Hydrographs 2014**

Generally groundwater levels were consistent through the reporting period with a slight rise towards the end of the year corresponding to higher rainfall. The spikes in data in May and again in July are attributed to when the sensors were retrieved to take download data.

A groundwater logger (BHW1) was installed in the old Tyldesley Colliery underground workings. The location of this monitoring site is shown in **Figure 4** and the monitoring results are shown in **Figure 8**. Minor fluctuations in the depth of water within the underground workings were observed during the reporting period which is consistent with previously recorded results.

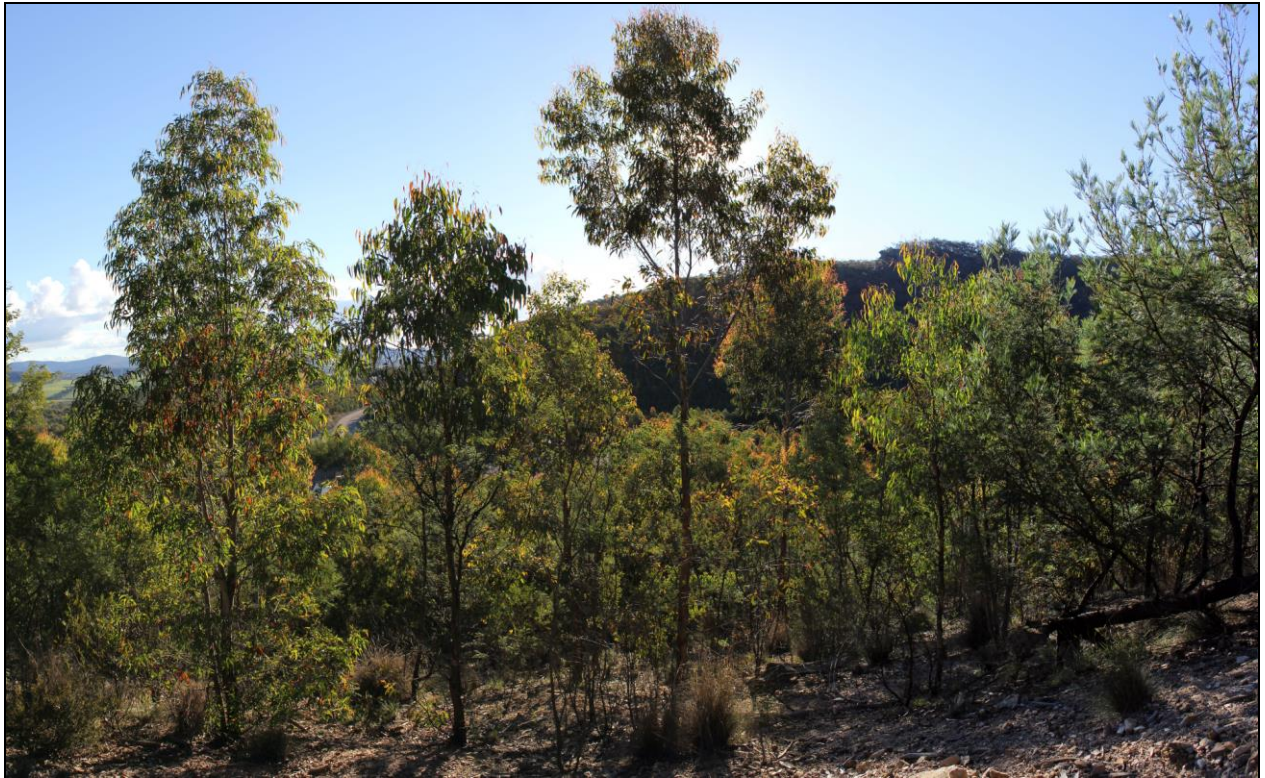
**Plate 5**  
**Strong canopy growth in 2004 rehabilitation, May 2014**

**Plate 5** and **Plate 6** show the successful established rehabilitation undertaken at the Cullen Valley Mine showing strong canopy growth and groundcover development respectively.

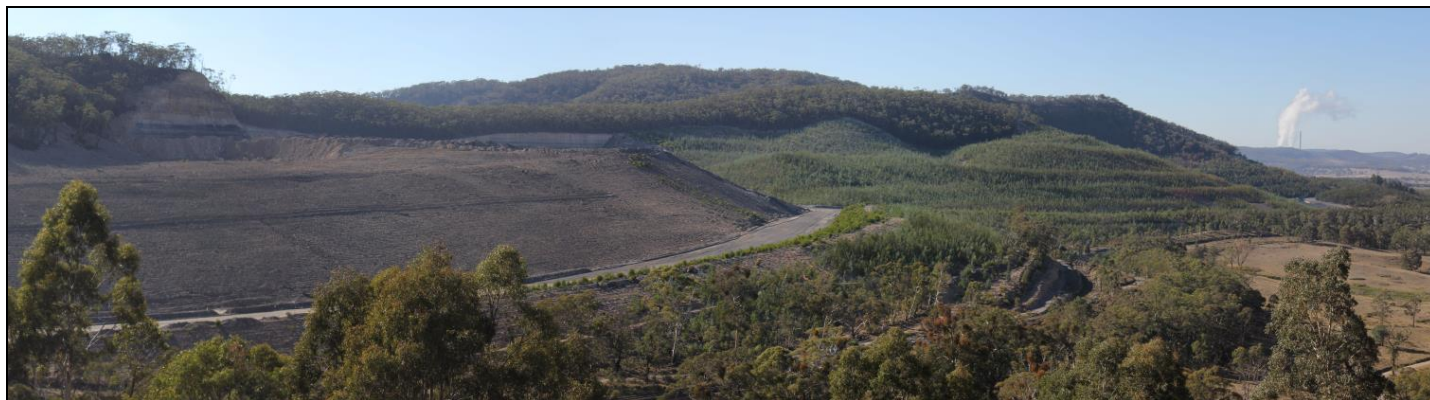
**Plate 7**  
**Progressive Rehabilitation at Cullen Valley Mine, February 2014**

Areas mined are progressively backfilled on a continual basis to form a profile similar to the pre-mining landscape. The following aerial photo (**Plate 7**) demonstrates the transitional progress from mining to rehabilitated land at the Cullen Valley Mine.
