# **INVINCIBLE COLLIERY ANNUAL REVIEW**

1 January – 31 December 2020

March 2021

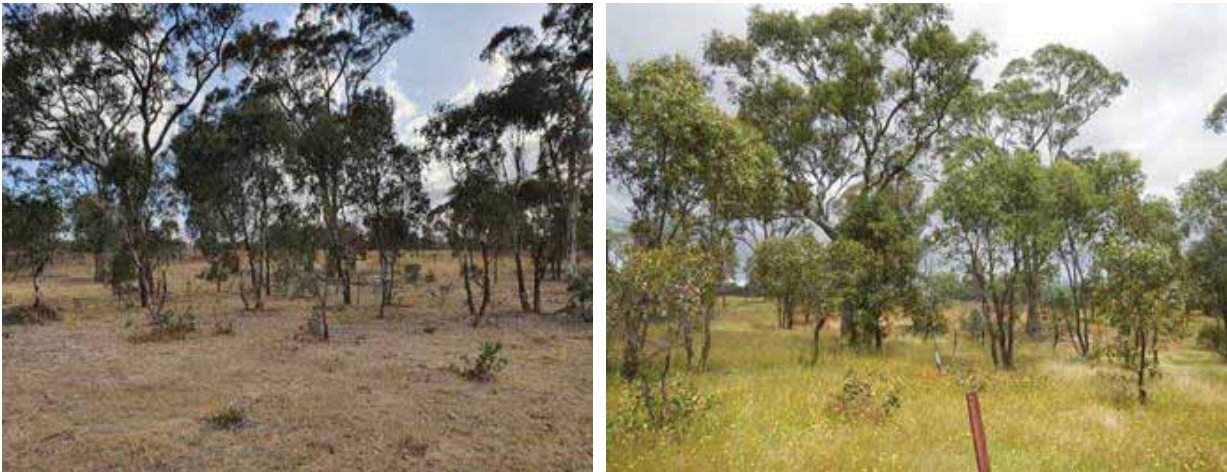
**Plate 6.2** Condition of BOA monitoring location B06 (Left – 2019; Right -2020)

All BOA monitoring sites have undergone substantial recovery following drought conditions experienced in the region since 2017. Native vegetation of the BOA is considered to be in moderate condition across both grassland and woodland habitats and is expected to continue to recover with the easing of drought conditions. The floristic composition and vegetation condition has increased for the majority of monitoring locations in 2020 compared to previous monitoring events which highlights the expected affect that rainfall and drought have on floristic diversity, and the ability for flora species to respond rapidly to favourable environmental conditions following a period of drought. All areas of remnant woodland demonstrated a substantial increase in the vegetative cover throughout the ground strata, and slight increase in the canopy and midstory strata (refer to **Plate 6.2**). Some of the monitoring sites have experienced impacts from bushfire in early 2020, which has resulted in the reduction of midstory and canopy cover and abundance, with some instances of sites with the complete canopy strata removed. However, coppicing and regeneration of tree species was evident at most sites indicating that those sites are recovering post-fire. Weeds experienced similar increases where exotic species were recorded in moderate to high abundances throughout most areas of woodland habitat. Eucalyptus recruitment was observed at most monitoring sites, where persisting saplings and juvenile eucalypts growing within the ecotone of woodland and grassland habitats were improving in health post-drought.

While the 2020 monitoring observed increased cover and abundance of native species it should be noted that the cover and abundance of these species is expected to decrease slightly in subsequent monitoring events as is typical of native flora species following a period of increased growth after a drought.

Given the native flora species diversity recorded in both grassland and woodland habitats during the 2020 surveys no management activities are recommended at the present time.

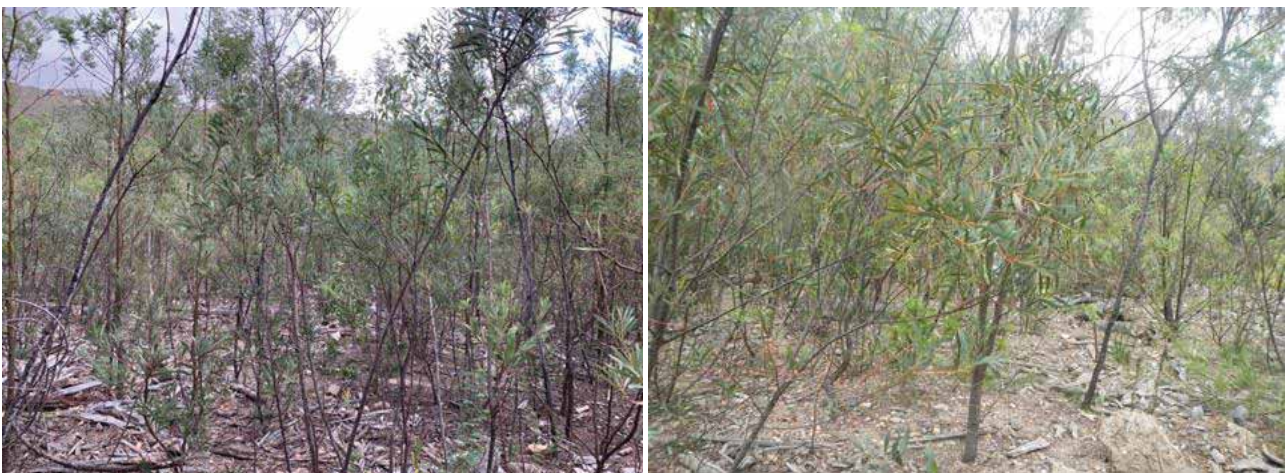
**Plate 6.3** Condition of Invincible Rehabilitation monitoring location R10 (Left – 2019; Right – 2020)

Monitoring in 2020 indicated that the overall vegetation condition and total species diversity of the Invincible Colliery rehabilitation areas increased compared to 2019 surveys. Species in the groundcover strata in particular, has shown a substantial increase in vegetative cover throughout all rehabilitation areas. Native grasses were abundant in cover and abundance within these areas with the most commonly recorded species being kangaroo grass (*Rhytidosperma spp.*) and speargrass (*Austrostipa spp.*), some of which demonstrated substantial flowering and seeding. Native forbs were also higher in abundance compared with 2019 survey results, which did not record forbs at some sites. Shrubs and young trees are recovering from die back following drought conditions (refer to **Plate 6.3**).

In 2020 the eastern rehabilitation areas generally demonstrated higher native species diversity and vegetation condition, as well as a greater density of established plants compared to the north-western rehabilitation areas which were established more recently. This is attributed with the age difference of these areas where the older areas of rehabilitation demonstrate a higher level of plasticity and resistance to drought. North-western rehabilitation areas exhibited reduced vegetation growth and ecosystem function where the severe die back of trees, shrubs and ground layer species contributed to the low quality of vegetation.
